SAWARA HISTORIC DISTRICT

# Steps Toward Recovery

from the Great East Japan Earthquake

The Ono River and Sawara Cityscape Preservation Association  
NPO 法人 小野川と佐原の町並みを考える会

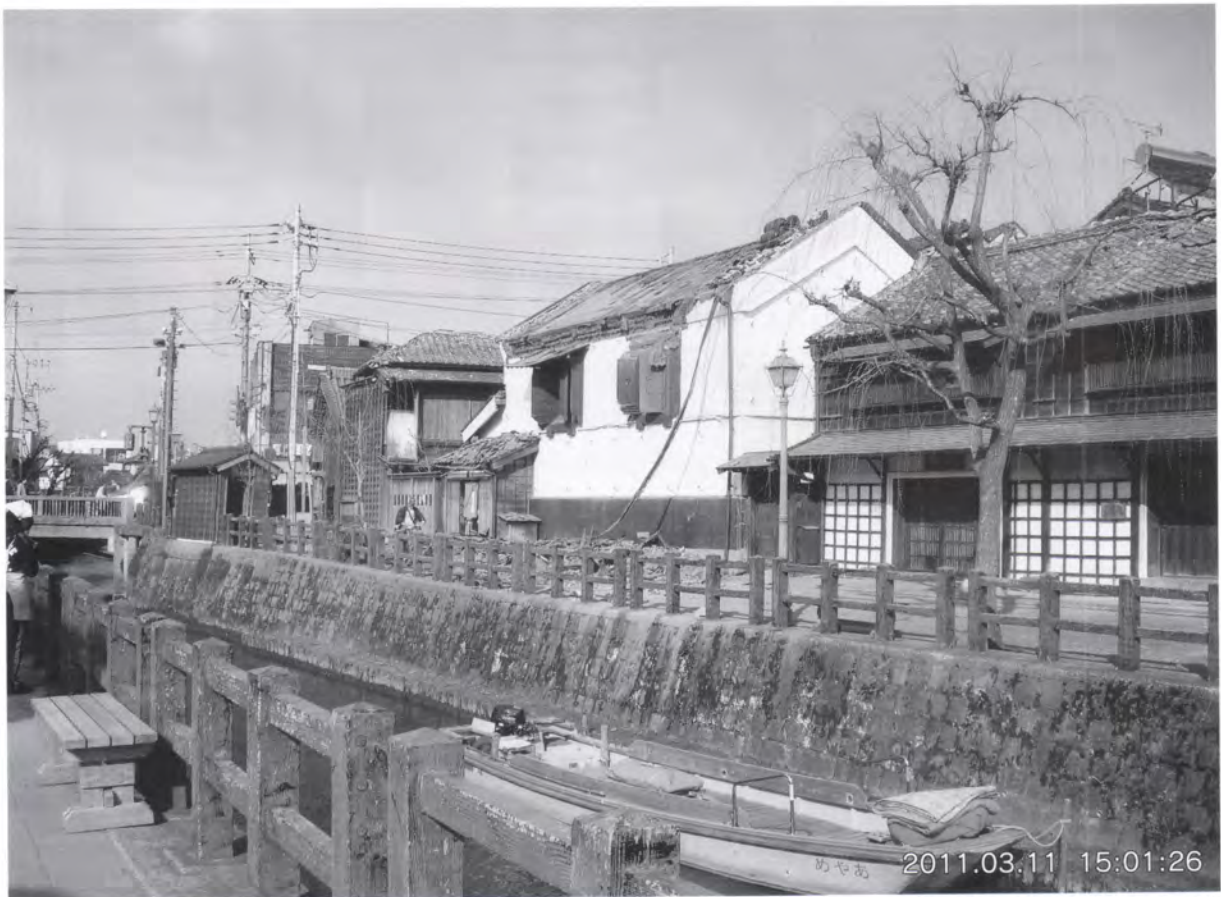
On the other hand, while there was no liquefaction observed in the historic district, one-third of the more than 300 *machiya* buildings from the Edo to early Showa eras were damaged on the roof ridge or roof tiles. There were also those with cracks or deformation in the walls. The 12 prefecture-designated buildings of 7 families were all constructed in the period from the late Edo to mid Meiji eras and were badly damaged owing to deterioration over time.

The traditional tiled roofs of these buildings had been covered by first placing mud, made by mixing clay with straw cut into small pieces and fermented, on the sheathing boards and then laying down the heavy roof tiles. These tiles became firmly attached onto the roof as the mud dried. However, after weathering of the mud over time and the roof tiles coming loose, severe shaking caused the tiles to slide and fall. Some say that this technique was adopted to protect the wood frame structure by shaking off the load of the heavy roof tiles. Damage to earthen walls was large as well. The 7 households with long family histories also have earthen-walled storehouses within their premises. The cause of severe damage to these earthen-walled structures possibly lies in the fact that they had not been regularly repaired or maintained for protection from rainwater.

地震直後の様子(松田佳久氏撮影)

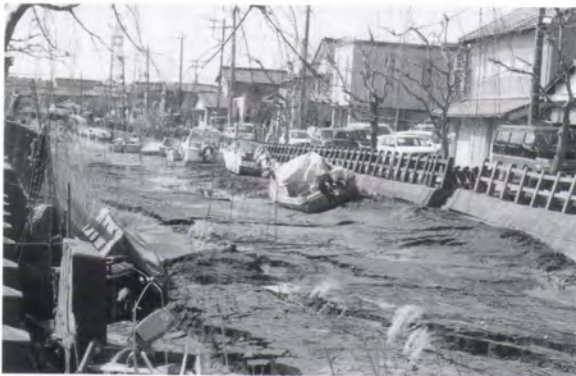
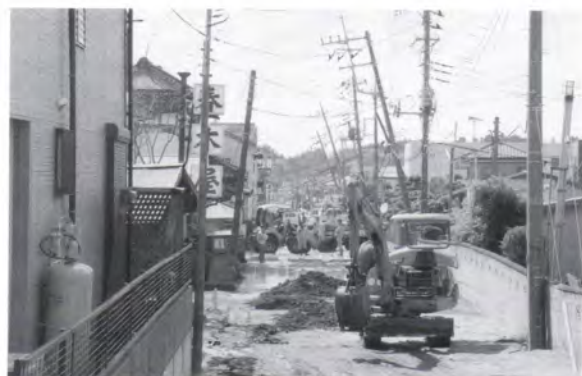
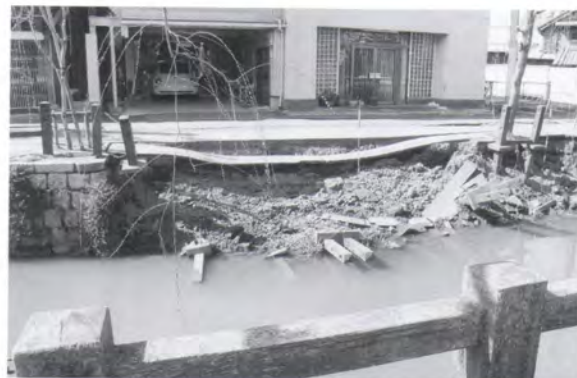
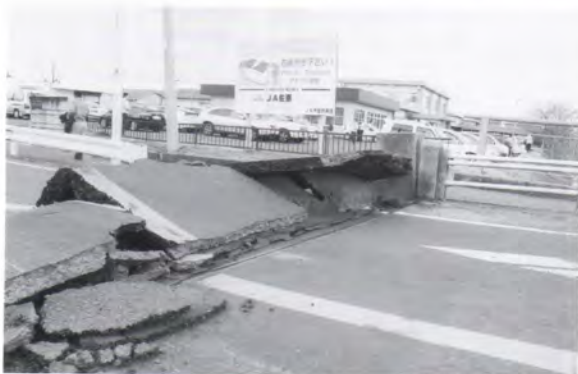
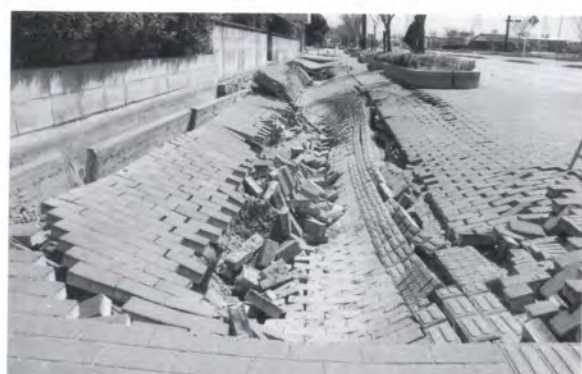
Because much of Katori City is located on the lowlands along the Tonegawa River with weak bearing ground, the quake of 5 higher on the Japanese seismic scale caused a wide range of damage to a total of 6,190 buildings, including residences toppled or leaning and roof tiles falling. Particularly, building damage seen in reclaimed lowlands and residential developments suffering liquefaction (3,500 ha) was great. Some lowland areas along the Tonegawa River and newly developed urban cores of Sawara and Omigawa were struck with loss of electricity and water-related lifelines, requiring residents to take shelters elsewhere for several months. Three years after the disaster, work is still underway for full recovery.

Damage due to liquefaction

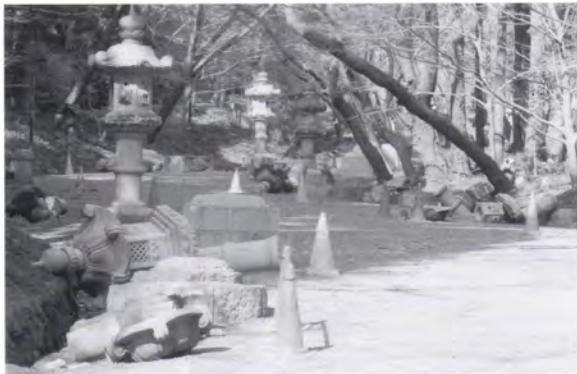
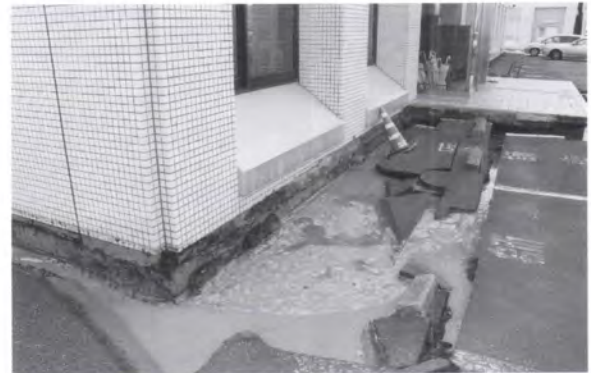
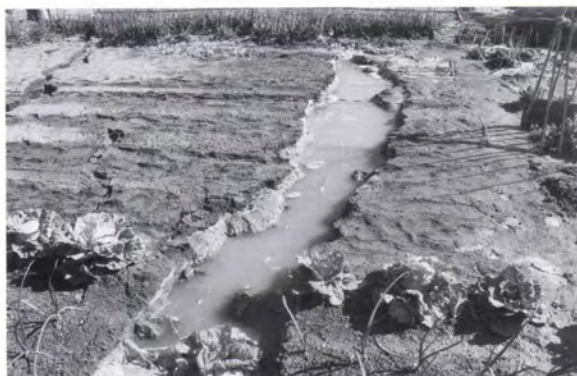
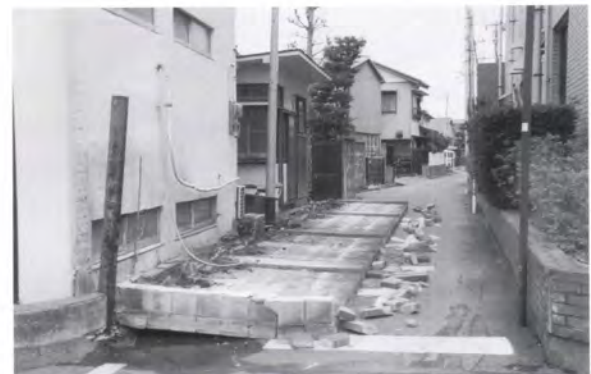
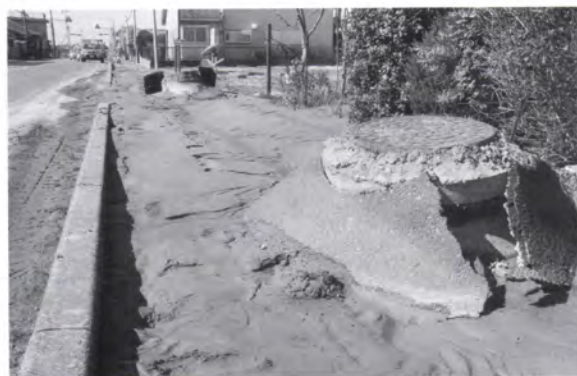
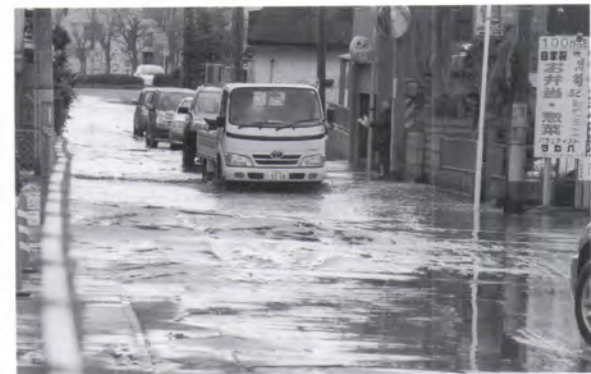
地震と液状化による被害

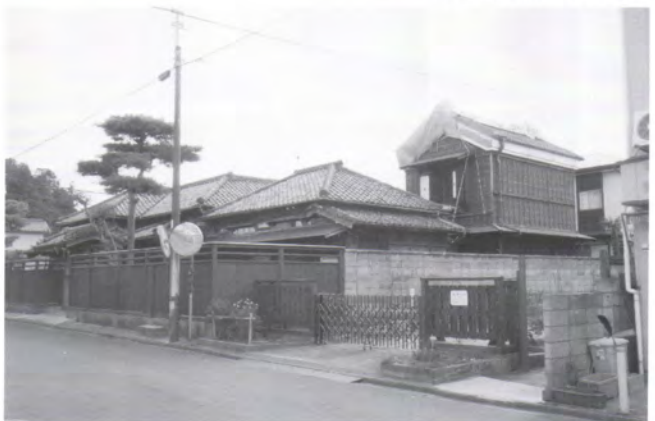
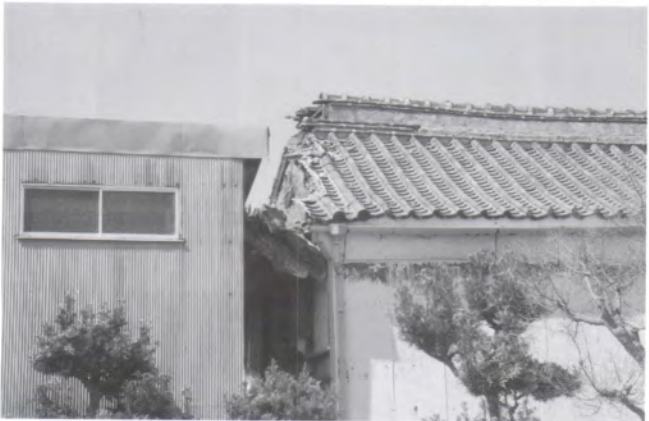
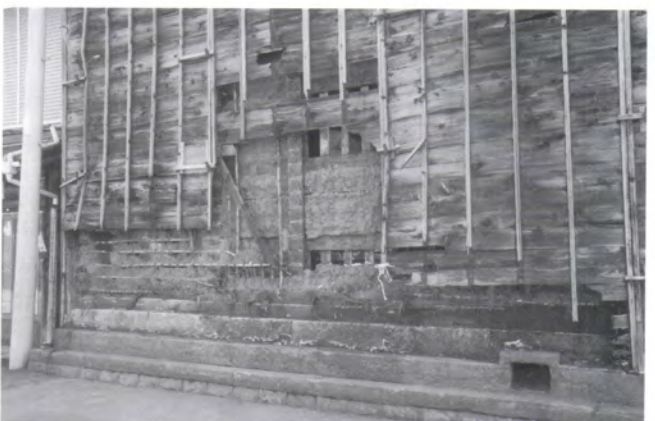
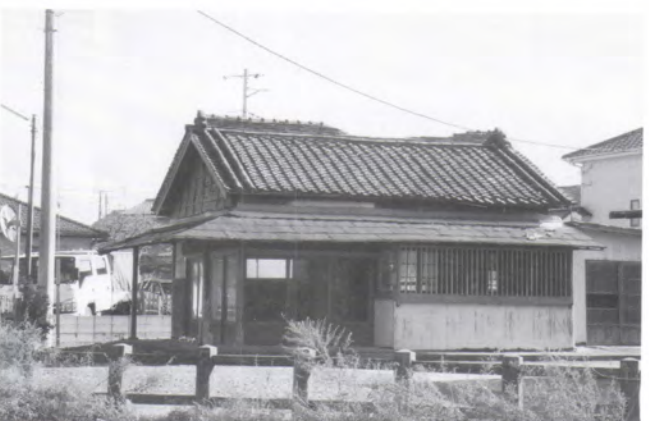
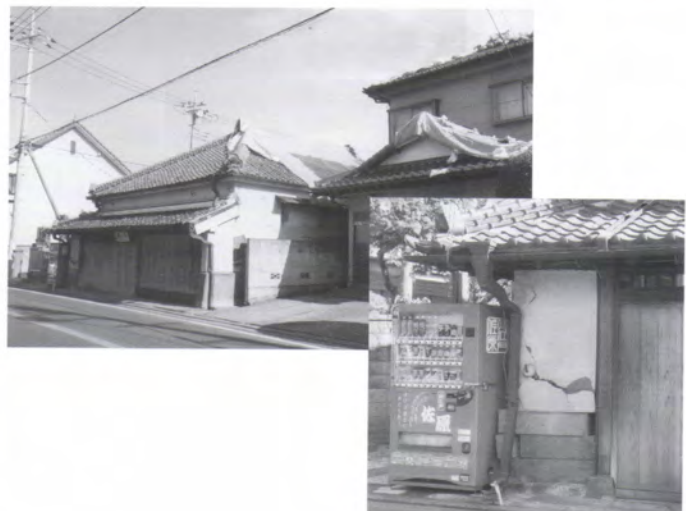
Building damage

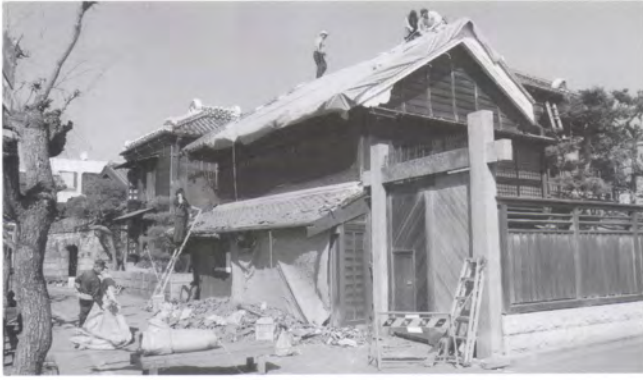
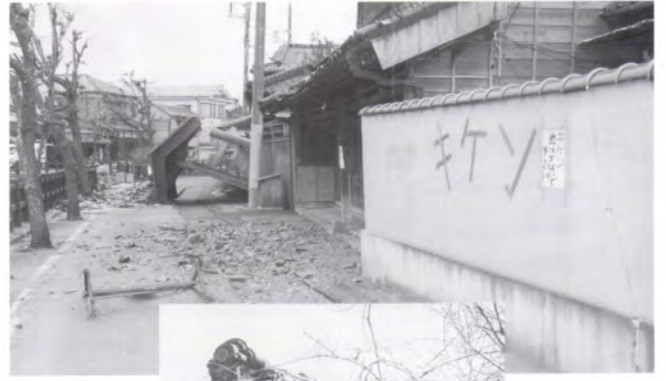
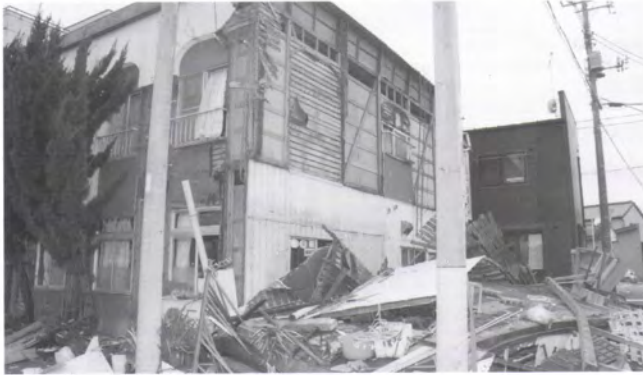
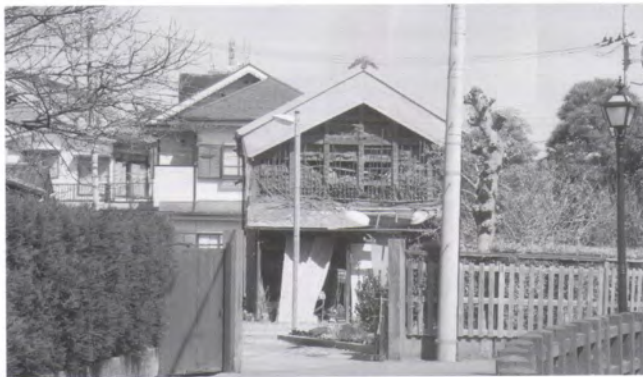
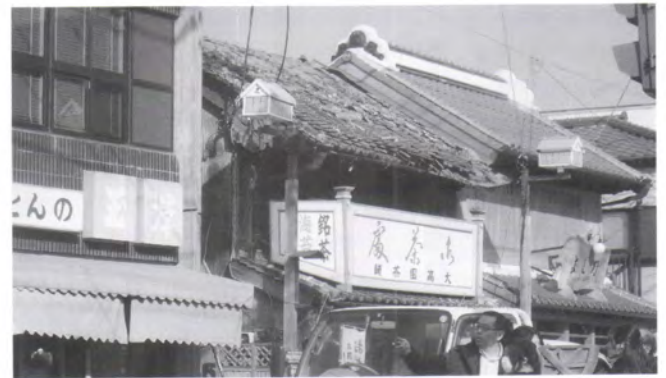
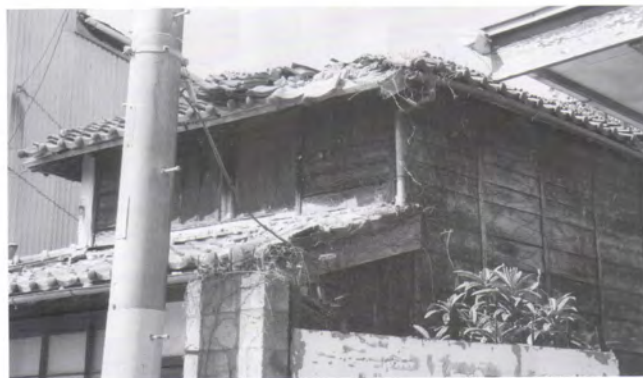
建造物の被害

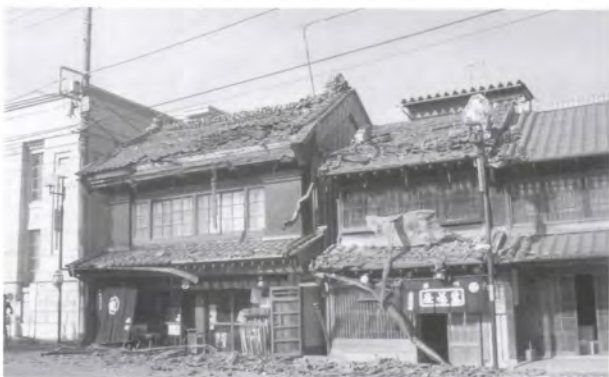
Extent of damage: [store] All roof tiles slipped and fell. The building leaned with cracks appearing on walls. [storehouse] Earthen walls cracked and fell. Some areas of the window shutter doors were broken.

Right after the earthquake / 被災直後

Restoration: [store] The sunken east side of the building was raised and straightened, foundations were stabilized, and the leaning structure was corrected and reinforced. The eastern *tatami*-matted floor that had been altered earlier was restored to the original style. As with all other buildings that were restored through this project, roof tiles of the same size as before were placed without the use of mud and tied in place with wire, and a wooden substrate was created to make up for the thickness of the mud layer. [storehouse] The wall substrate was repaired and finished with plaster.

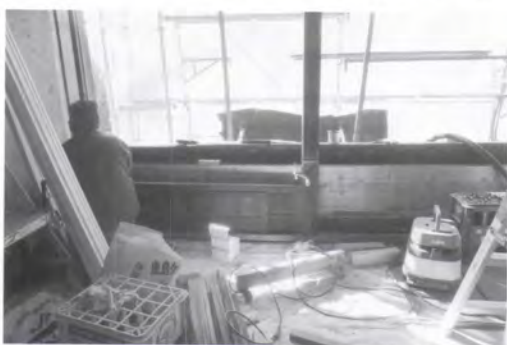
Restoration of the store, second floor  
店舗 2 階修理

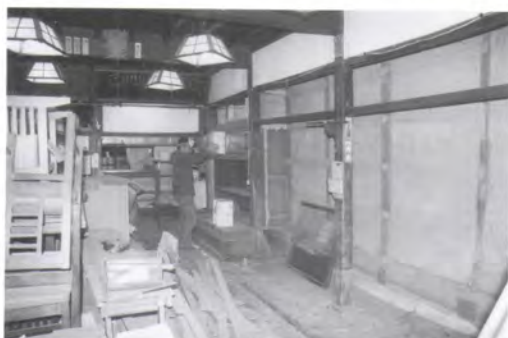
Restoration of the store, east wall  
店舗東側面修理

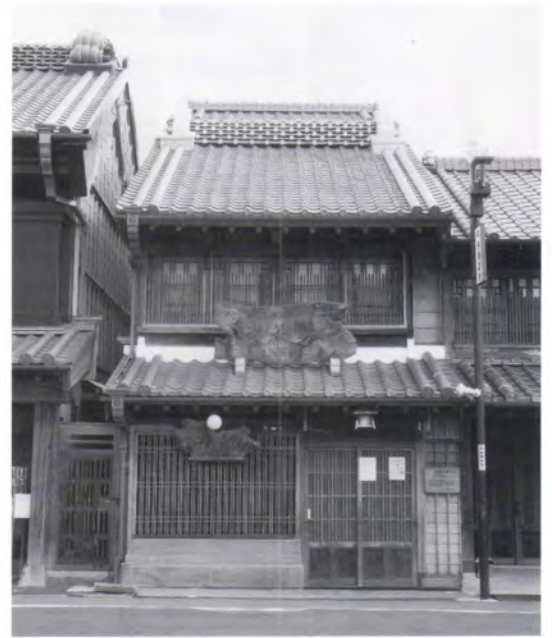
Repairs on foundation and walls / 基礎・壁修理

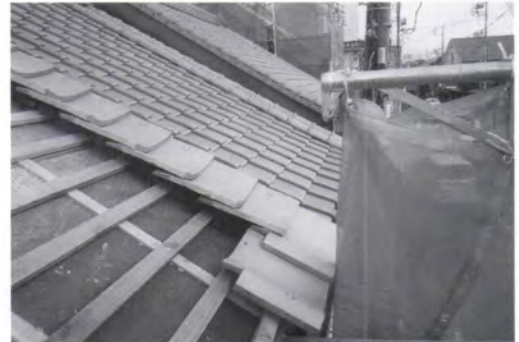
Roof repairs / 屋根修理

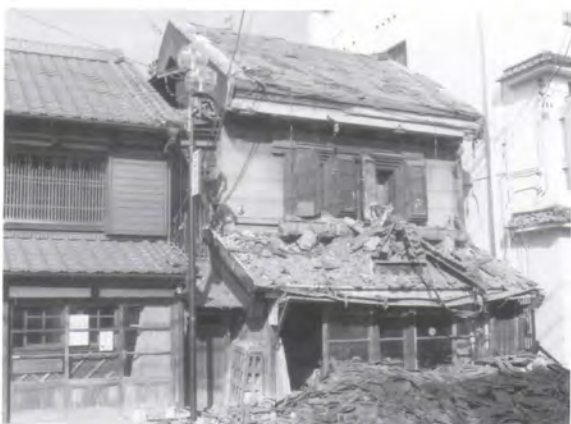
Extent of damage: Roof tiles of the main roof and lower eave fell. Here, sheathing boards were first covered with mud, plastered, and the roof tiles before the earthquake had been set in place with mud. Fallen roof tiles damaged the walls connecting the store to the back building, where rainwater seeped in and caused secondary damage.

Right after the earthquake / 被災直後

Restoration: The back building and the connecting structure in between were first removed to stop water leaks and for repairing exterior walls. Floorboards of the first and third floors were replaced, while those of the second floor were reinforced. Second floor *tatami* mats were replaced. The characteristic “Ko-Edo” roof tiles were reproduced and carefully reroofed, placing them without using mud.

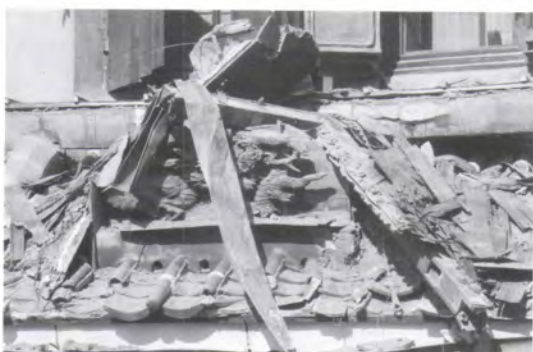
Damage to sculptural sign board / 看板彫刻

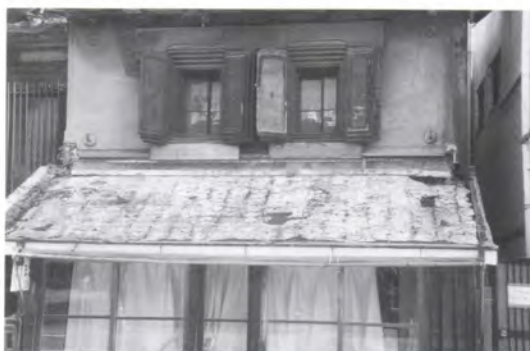
Roof substrate of front eave / 下屋庇下地

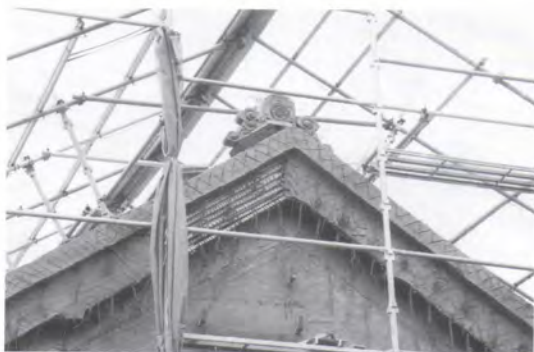
Repairing the storehouse gable / けらば修理

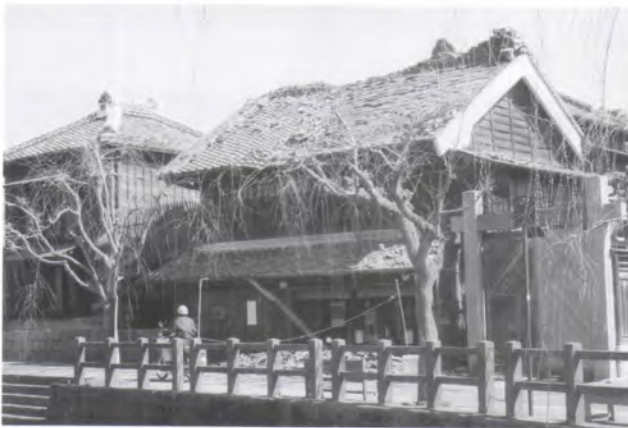
Extent of damage: [store] Roof tiles of the main roof slipped and fell, damaging the lower eave. [side storehouse] Though the recently reroofed roof was unharmed, damage was seen in earthen walls and shutter doors. The reception room of the undesignated area also suffered damage in the roof and walls.

Right after the earthquake / 被災直後

Restoration: [store] The leaning structure was corrected and reinforced. The roof was reroofed. [side storehouse] The displaced “*torii*-style” door frame was jacked back up. [reception room] The leaning wood frame was corrected and reinforced. The roof was reroofed.

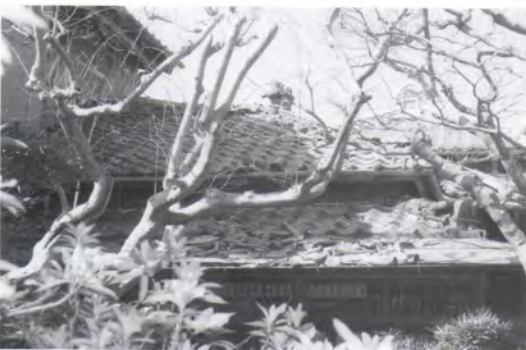
Damage to reception room roof / 奥座敷屋根被害

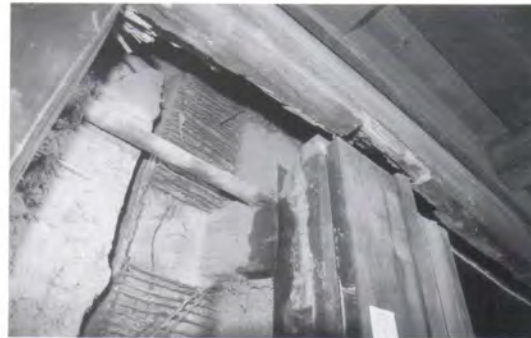
Details of door damage / 扉内側

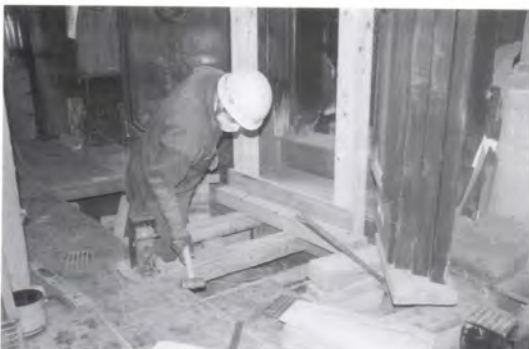
Doors were jacked up and reinforced with a frame  
ジャッキアップして補助枠

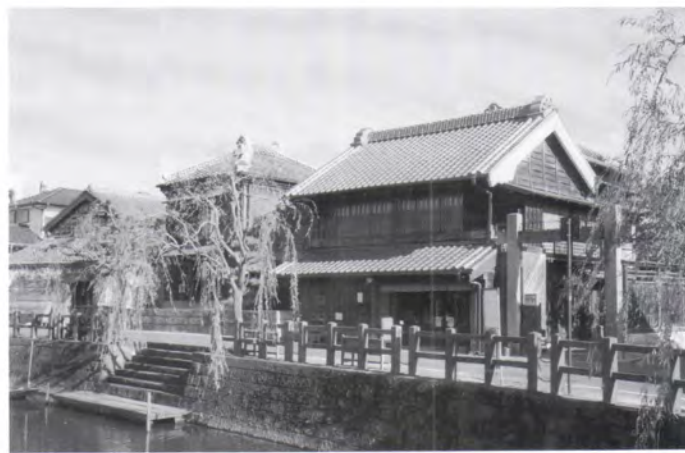
Damage to store roof structure  
店舗小屋組被害

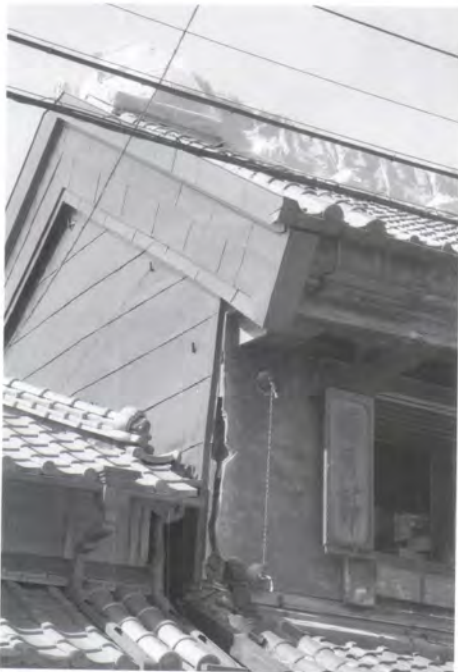
Extent of damage: [store] Roof tiles became misaligned, earthen walls fell, and the structure leaned. [library storehouse] The upper third floor wood frame structure was damaged, while the lower stories remained unharmed.

Damage to main ridge and earthen walls  
棟、外壁に被害

Restoration: [store] The structure was reroofed and the front lower eave repaired with reinforcement. Earlier, only the roof of the backside was to be reroofed, but extensive damage was later discovered in the roof facing the street, requiring reroofing of the entire roof. To place roof tiles without using mud, a wooden substrate to compensate for the thickness of the mud layer was created. Tiles reproduced in the same size were used. The original ogre tiles of the main ridge that remained undamaged together with the surrounding plasterwork were reused. [library storehouse] The roof was reroofed and interior walls were repaired.

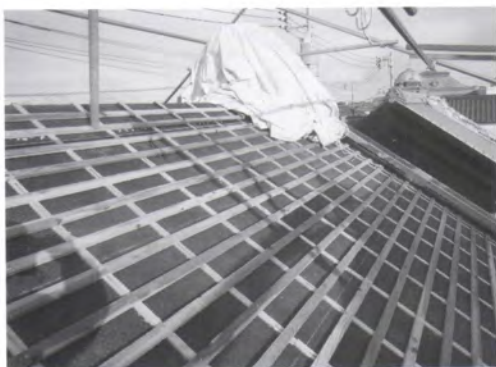
Preparing substrate for roof tiles / 瓦葺き下地

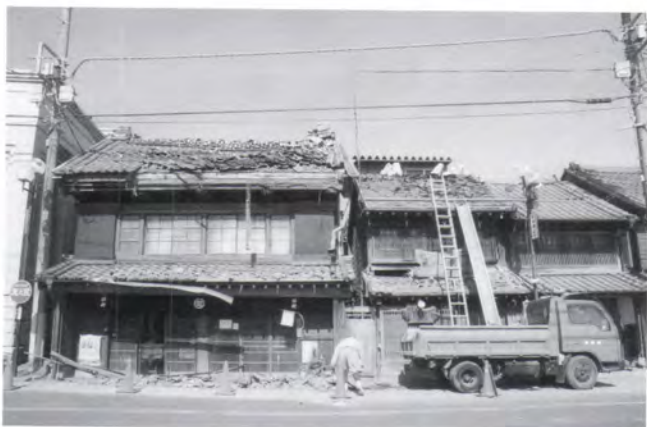
Extent of damage: About half of the roof tiles fell with the roof ridge and the ogre tiles became displaced. Cracks and loosening of mud layers were seen in the walls and gables. The roof of the residence became misaligned.

Right after the earthquake / 被災直後

Restoration: All roof tiles were removed and replaced. Reroofing was done without using mud to assure safety, by creating a wooden substrate in place of the thickness of the mud layer. The interior walls and ceiling, finished with modern wall covering on plywood before restoration, were restored back to their original finishes.

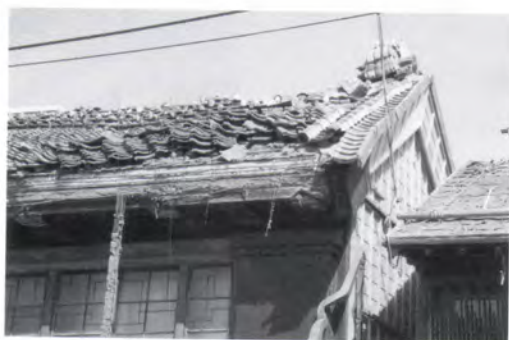
Damage to store roof / 店舗屋根被害

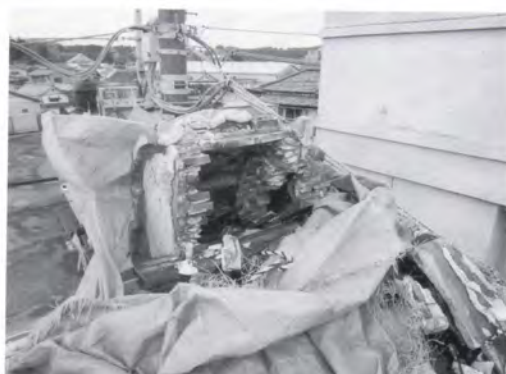
Plasterwork around ogre tiles / 影盛り

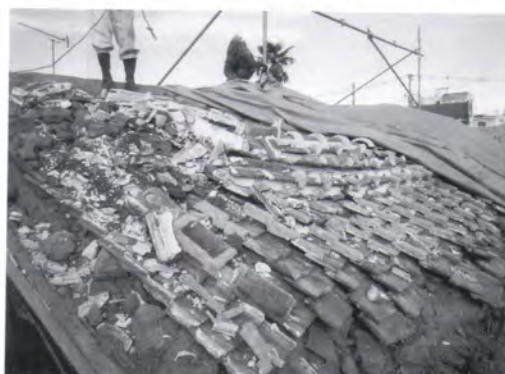
Damage to roof tiles / 屋根瓦の被害

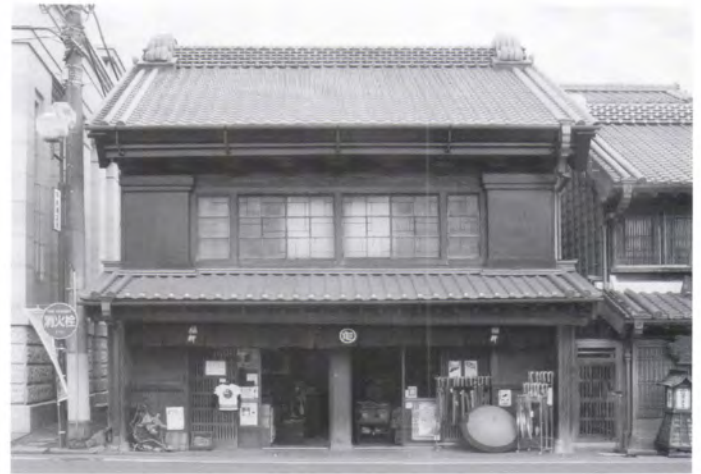
Main ridge of store annex / 平屋棟積み

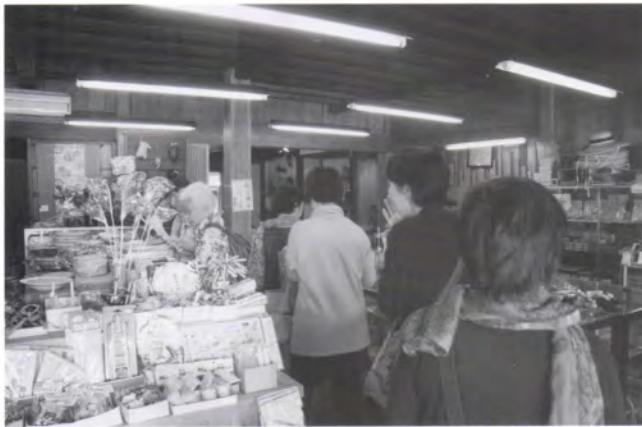
Store after restoration / 復興なった店舗

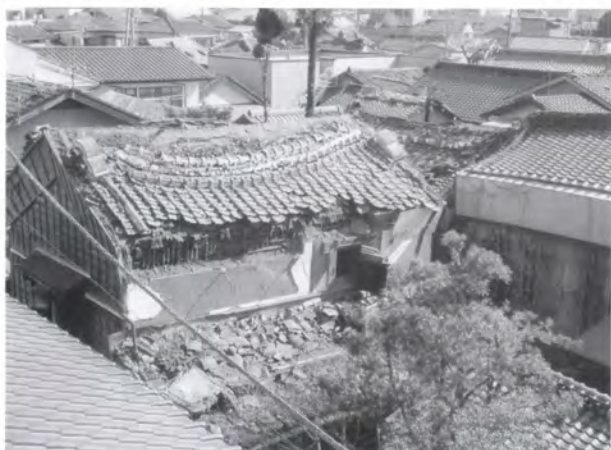
Extent of damage: The roof ridge fell dragging about half of the roof tiles with it, damaging the projection along the gable ends and the lower eaves. The earthen walls were severely cracked with fallen wall material pushing off the wooden siding.

Right after the earthquake / 被災直後

Restoration: Roof tiles were removed and damaged areas of the north wall were disassembled. A temporary roof was built to protect the building undergoing restoration from rain and wind. The walls were repaired following traditional methods involving 24 procedures, from weaving the bamboo substrate to applying mud in multiple layers. The sand plaster to be used for the lower walls employed plaster bits originally used in the same area of this building as infill material, mixing this together with local mud, gravel, sand, lime, and calcium chloride. The roof tiles were placed without using mud. It was fortunate that the wall openings remained undamaged, for their repairs would have required labor-intensive work. Records of this restoration will be of value in the years to come, as full-fledged repairs of earthen-walled storehouses had not been seen in Sawara in a long time.

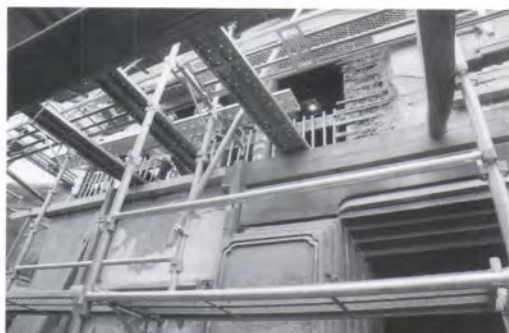
Storehouse, front façade repairs / 土蔵正面修理

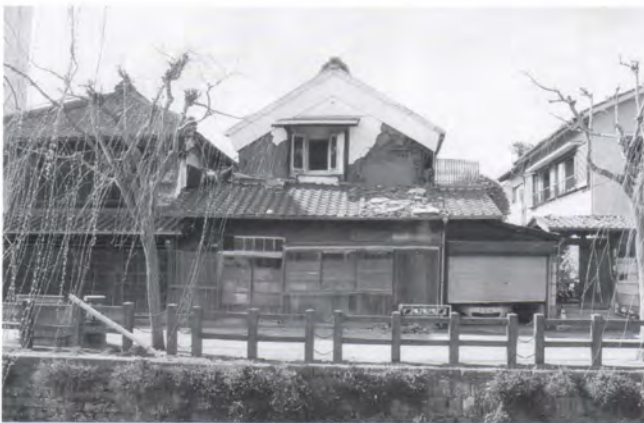
Extent of damage: [store] The roof, walls, and fittings were damaged in ways similar to the storehouse. [storehouse] The greatest damage was seen in the storehouse in which the roof tiles became misaligned, a part of the roof ridge fell, and window openings cracked. The lower walls became loosened and fell while the upper walls also cracked and fell, requiring repairs entirely.

Right after the earthquake / 被災直後

Restoration: [store] Partial repairs were undertaken on the roof, walls, and fittings. [storehouse] The roof substrate was repaired and then reroofed without using mud. All mud layers were first removed from the walls. The lower walls were repaired first, then the upper walls were restored from the bamboo lathing.

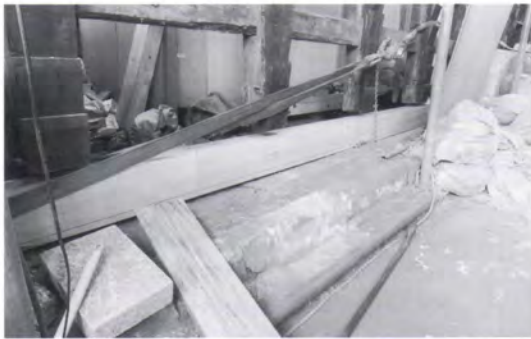
Foundation repairs / 土台修理

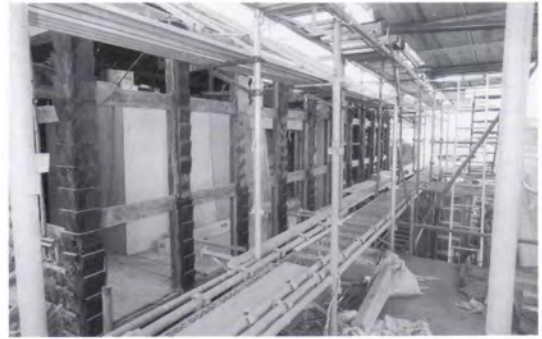
Removal of earthen-wall / 壁土を除去

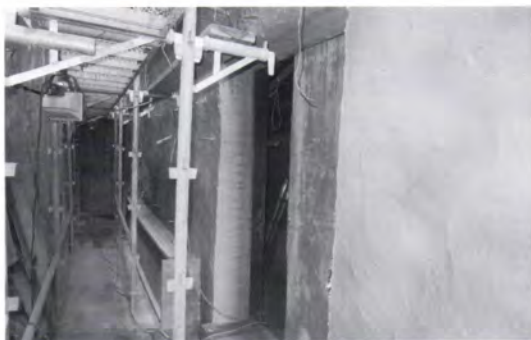
Entrance repairs / 入口部修理

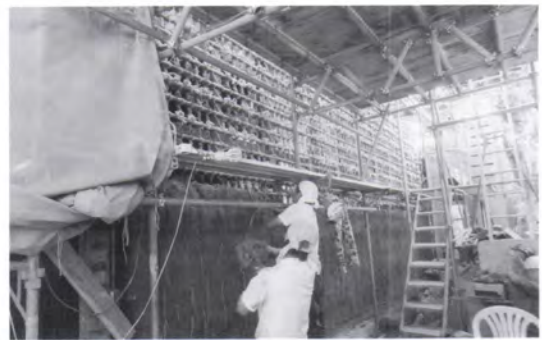
Wall substrate and application of mud  
小舞と荒壁打ち

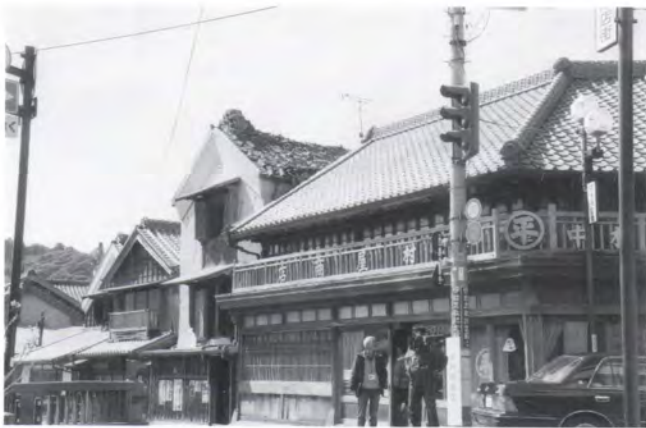
Extent of damage: [store] The roof was damaged in the area connected to the storehouse. [storehouse] Much of the damage was seen in the storehouse with the roof ridge falling and roof tiles becoming loose. Cracks in walls caused them to fall.

Right after the earthquake / 被災直後

Restoration: All roof tiles of both structures were removed and replaced setting them without the use of mud. [storehouse] The exterior walls covered with metal sheeting before restoration were restored to the original white plaster finish, which was discovered remaining on the wall facing the road. The heavily damaged walls facing the store and on the backside were refinished after first repairing the lower layers. On the other hand, with the interior walls, their surfaces were only cleaned to remove staining from rainwater ingress right after the earthquake.

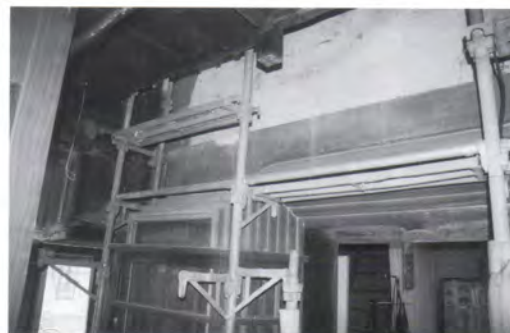
Entrance / 入口部

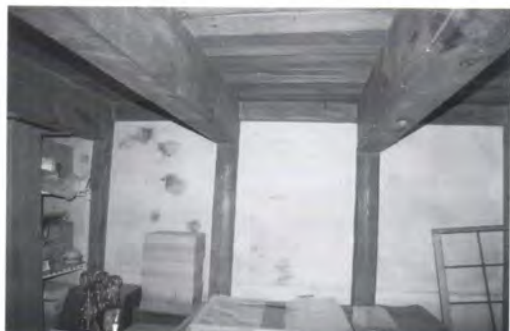
Staining from rainwater / 雨水によるしみ

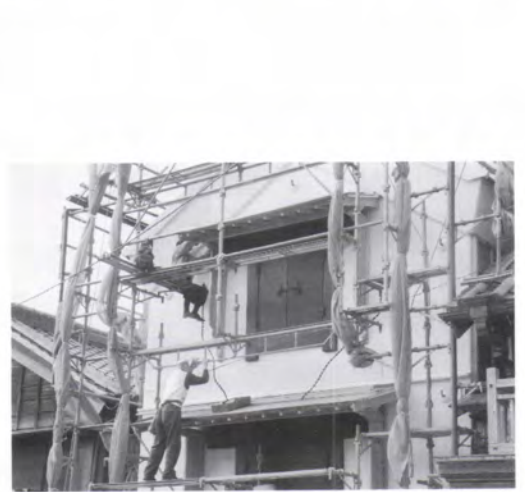
Plaster finish / 漆喰仕上げ
